Legal and Ethical Accountability in Occupational Safety: An Evaluation of Compliance Gaps Regarding Noise Hazards in Plastic Recycling Operations

Jomark F. De Paz ^{1*}, Jeremy C. Celoso ¹, Marvin O. Mallari ¹, Camilo B. Cadelina ¹

¹ Nueva Ecija University of Science and Technology

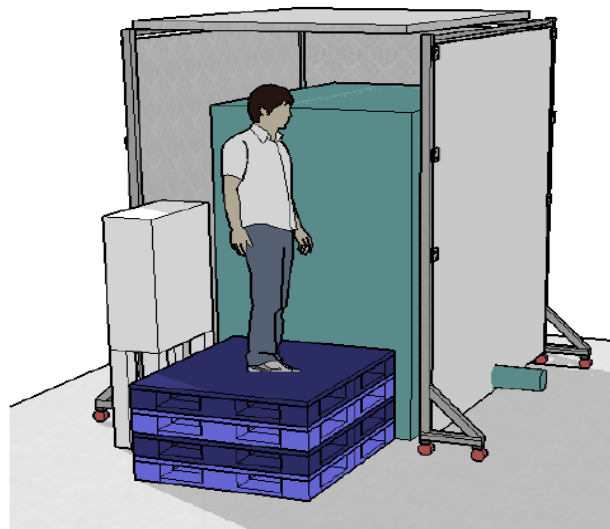
Figure 1. Barrier Design Draft

To reduce equipment noise, the proposed design involves installing barriers that enclose the back and sides of the machine. The front will remain open to allow operators to access the platform for feeding plastic materials into the processor. At the request of the company, the sides of the platform will also remain unobstructed to ensure the worker's range of motion is not restricted. Additionally, a top cover will be installed on the machines to block sound from reflecting or diffracting off the corrugated metal roofing, which would otherwise redirect noise back toward the staff.

The construction of each partition will involve a combination of various materials and specialized noise blankets intended to maximize sound absorption. Despite these plans, the company has restricted production to a single prototype because of constraints regarding both time and funding. This barrier will serve as a test case to evaluate the effectiveness of different design features and material configurations before further implementation is considered.

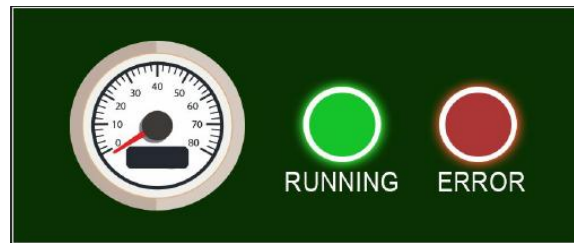
- **Visual Status Indicators:** Implementing RPM gauges and light status indicators (Green for running, Red for error) removes the perceived need for auditory monitoring, allowing workers to maintain hearing protection while remaining aware of machine conditions.

Moreover, the shift towards the use of Visual Status Indicators (RPM gauges and light indicators) constitutes a technical development in terms of monitoring operations. According to Balagtas and Mallari (2025), the digital leadership concept plays an essential role in making the process more efficient. Therefore, by implementing digital leadership, it will be possible to handle the transition of the monitoring process from the auditory system to the digital visual system.
